工事名 もみじが丘アパート2号棟長寿命化工事

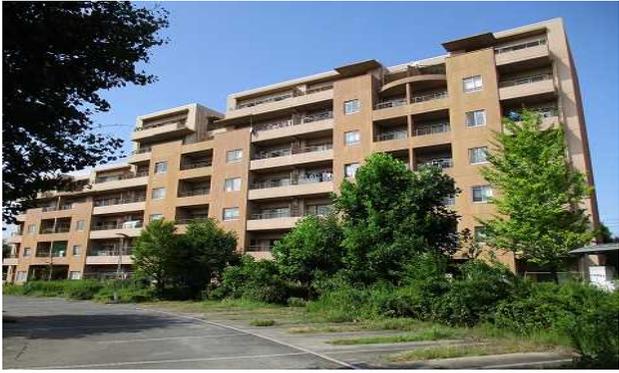
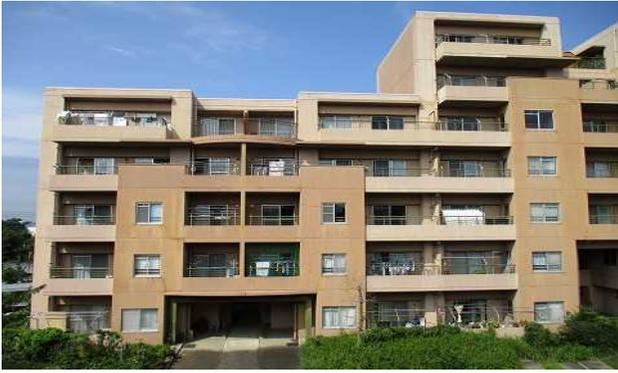
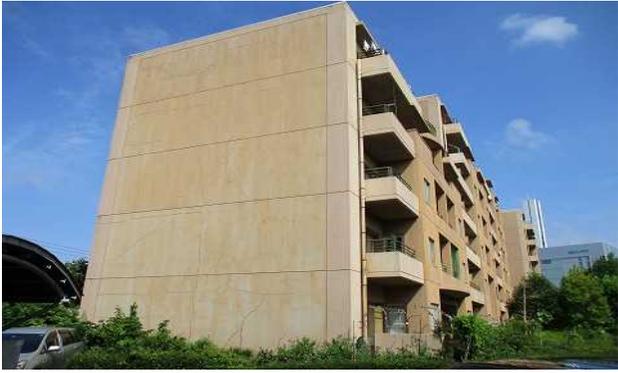
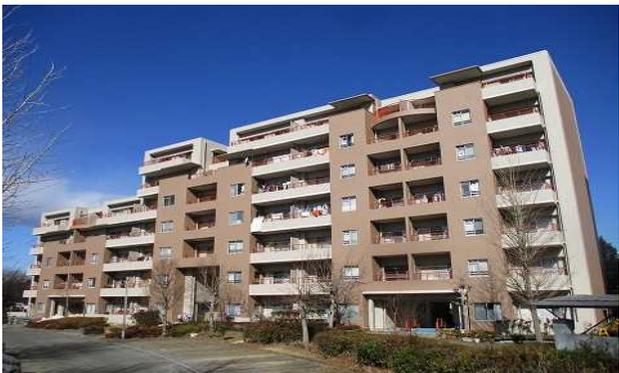
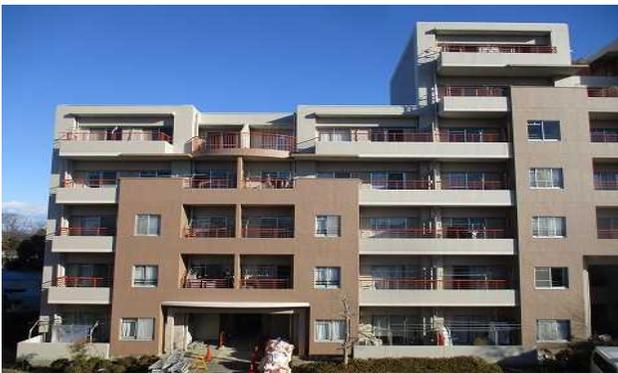
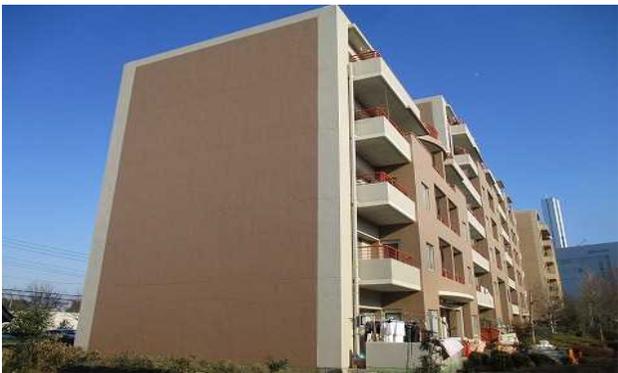
【外壁改修】 外壁の塗替え → 耐久性の向上	【外壁改修】 外壁の塗替え → 耐久性の向上	【外壁改修】 外壁の塗替え → 耐久性の向上
工 事 実 施 前

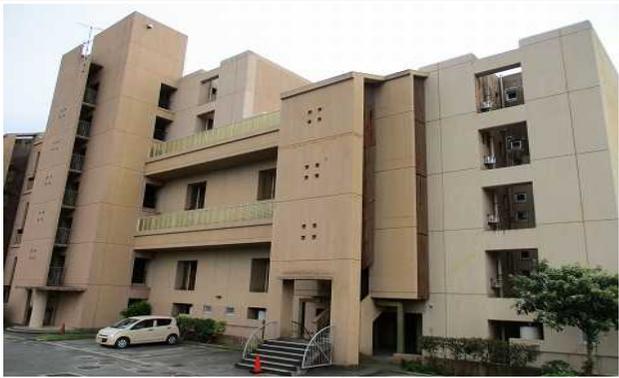
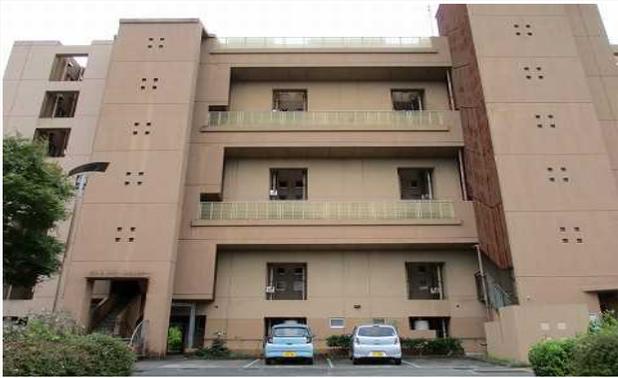
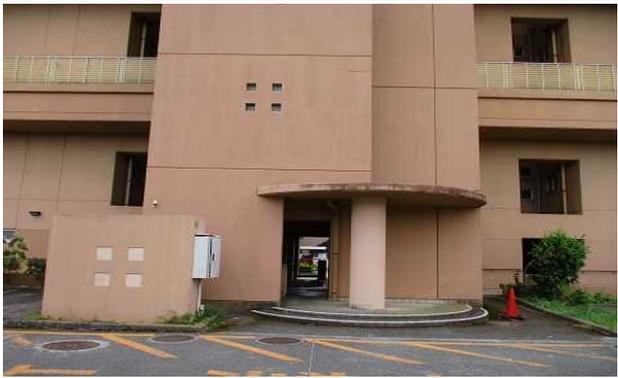
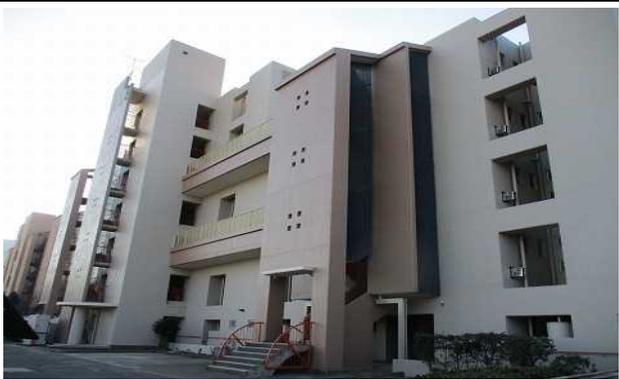
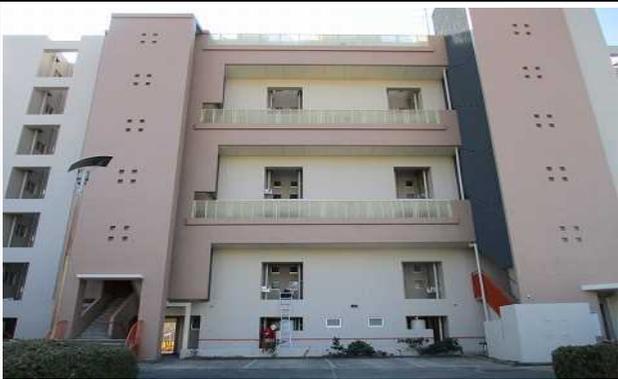
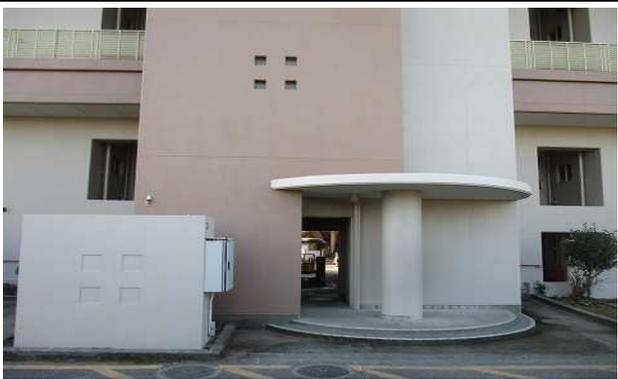
【外壁改修】 外壁の塗替え → 耐久性の向上	【外壁改修】 外壁の塗替え → 耐久性の向上	【外壁改修】 外壁の塗替え → 耐久性の向上
工事実施前

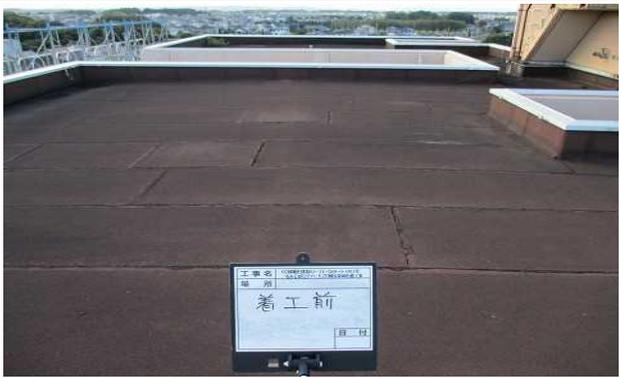
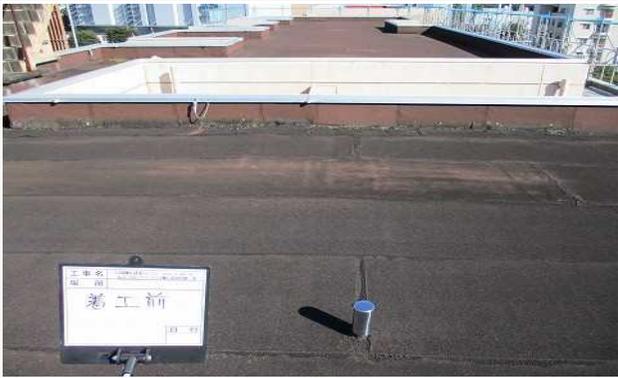
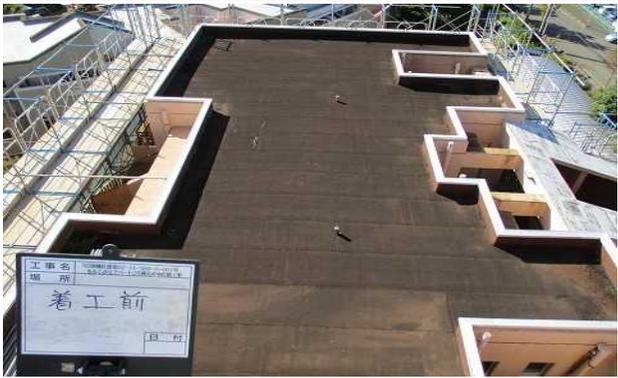
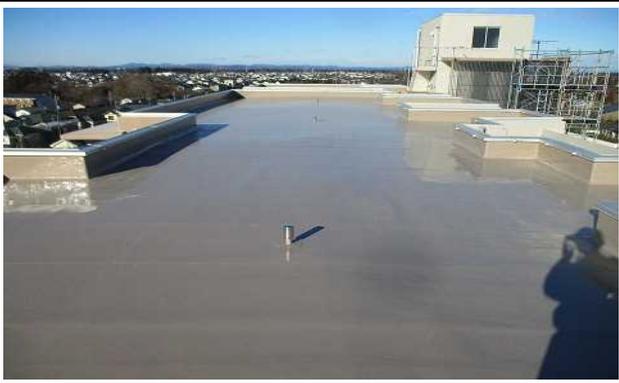
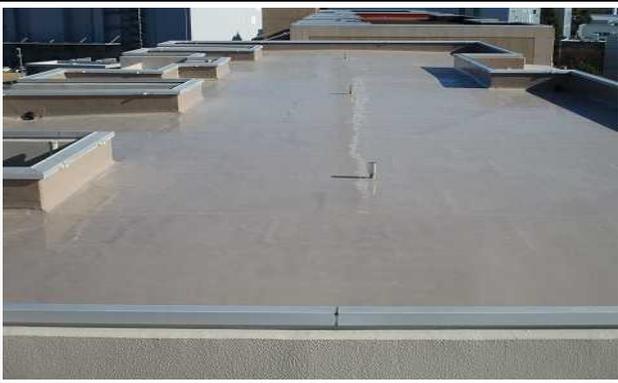
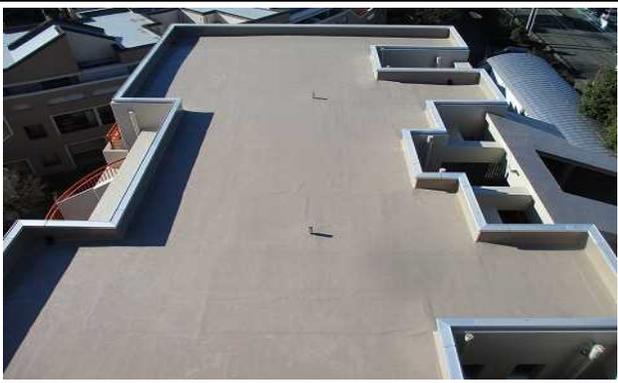
【防水改修】 屋上防水の塗替え → 耐久性の向上	【防水改修】 屋上防水の塗替え → 耐久性の向上	【防水改修】 屋上防水の塗替え → 耐久性の向上
工事実施前

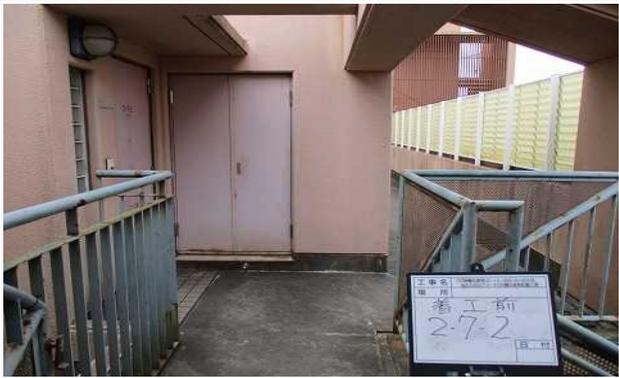
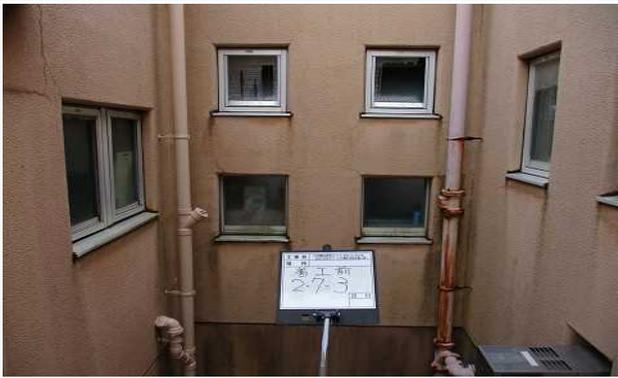
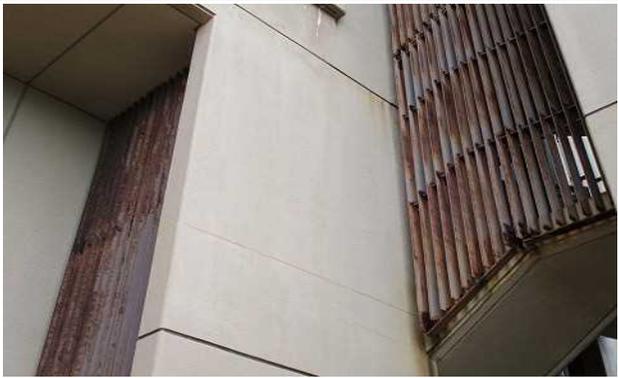
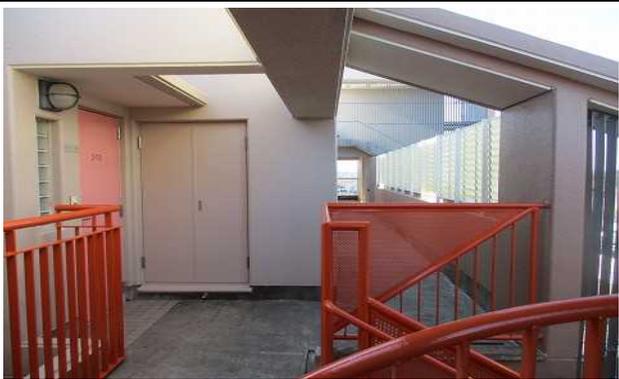
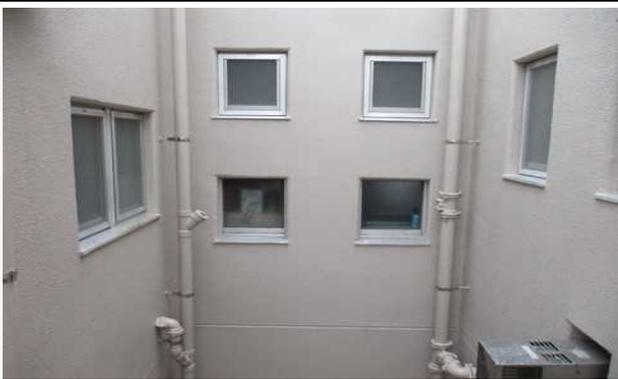
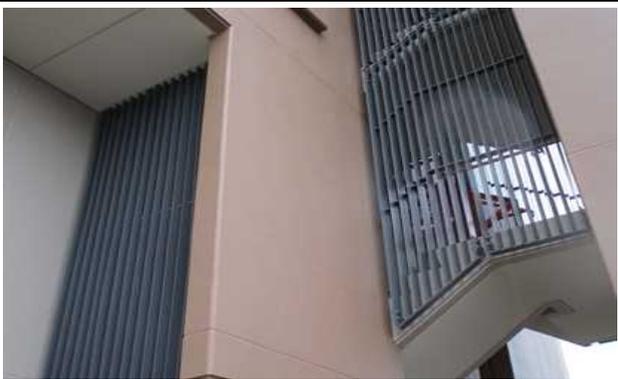
【塗装改修】 鉄部の塗替え → 耐久性の向上	【塗装改修】 配管の塗替え → 耐久性の向上	【塗装改修】 格子の塗替え → 耐久性の向上
工 事 実 施 前

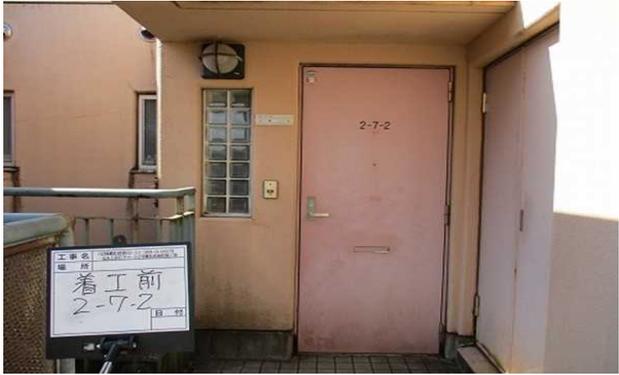
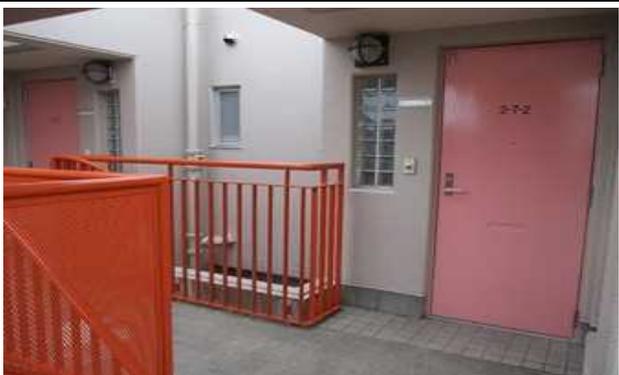
【塗装改修】 玄関扉の塗替え → 耐久性の向上	【防水改修】 防水の塗替え → 耐久性の向上	【塗装改修】 配管の塗替え → 耐久性の向上
工事実施前
